FINAL FORMER MARINE CORPS AIR STATION (MCAS) TUSTIN Base Realignment and Closure (BRAC) Cleanup Team (BCT)

27 April 2017 Meeting Summary

<u>Former MCAS Tustin, California. BCT Update. April 27, 2017. Operable Unit (OU)-1A and 1B</u> <u>Groundwater Hydraulic Containment Remedy (Presented by Mr. Pribyl, Navy PM) (Attachment 2)</u>

Update: Soil Vapor Intrusion Remedial Design Supplemental Assessment— Carve Outs (CO) 5 and 6 Former Marine Corps Air Station (MCAS) Tustin

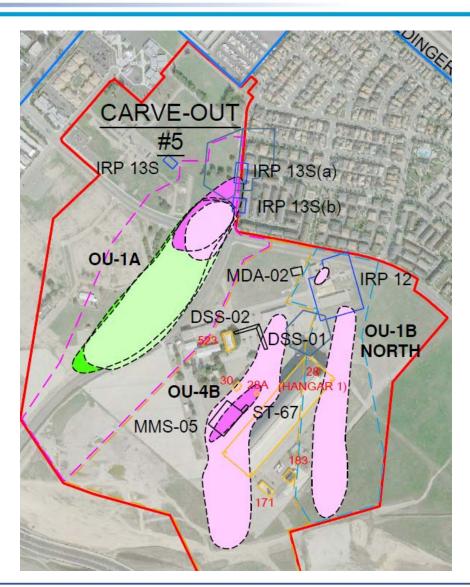
Background –Source Areas, COCs and Remediation – Carve Out 5

•OU-1A

- 1,2,3-TCP, TCE and breakdown products
- Includes: Hot Spot Groundwater
 Extraction and Hydraulic Containment,
 Performance Monitoring, ICs
- No Further Action (NFA) for soil

•OU-1B North

- TCE and breakdown products
- Includes: Hot Spot Groundwater
 Extraction and Hydraulic Containment,
 Performance Monitoring, ICs
- NFA for soil

OU-4B Mingled Plumes Area

- TCE and breakdown products
- Includes Insitu Bioremediation (ISB)
 Performance and Natural Attenuation
 Monitoring, ICs
- NFA for soil

The slide includes a figure showing sites included in Carve-Out 5. He explained that OU-1A is a mix of contaminants, specifically 1,2,3-trichloropropane (TCP), represented by the larger green plume in the figure, and trichloroethene (TCE), represented by the smaller plume in the figure. Mr. Pribyl explained that the remedies (groundwater extraction focusing on hydraulic containment) selected for OU-1A and -1B North are similar. At both OUs the Navy conducts performance monitoring and implements institutional controls (ICs) to prevent the domestic use of groundwater. The only difference between the two OUs are the types of contaminants being treated. He noted that 1,2,3-TCP is not present in OU-1B North.

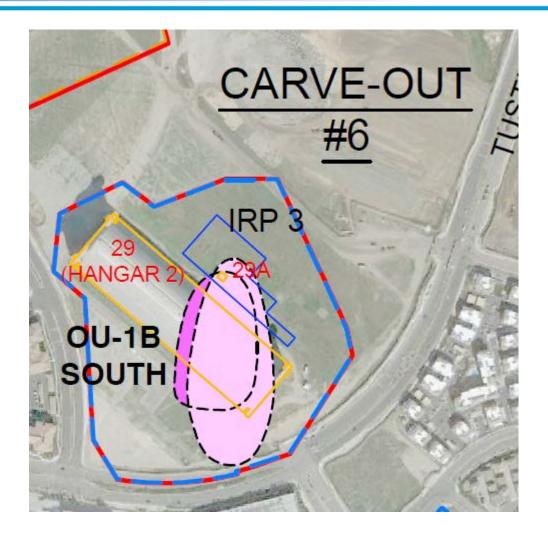
Background –Source Areas, COCs and Remediation – Carve Out 6

•OU-1B South

- TCE and breakdown products
- Includes: Hot Spot Groundwater
 Extraction and Hydraulic
 Containment, Performance
 Monitoring, ICs
- NFA for soil

The figure shows the sites included in CO-6. Mr. Pribyl described how CO-6 and CO-5 are two of the last COs on the entire base at Former MCAS Tustin. He explained that the remedies at OU-1B South and North are the same. At OU-1B South, the contamination consists of TCE with some higher concentrations of breakdown products. The remedy at OU-1B South is groundwater extraction and hydraulic containment, with performance monitoring and ICs. There is no further action for soil at OU-1B South.

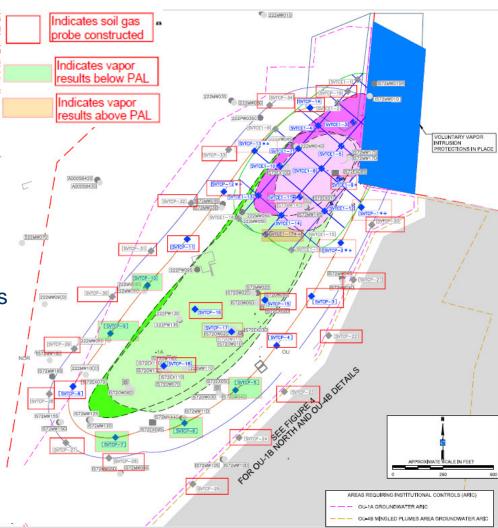
•1,2,3-TCP Plume

- -37 primary and step-out soil gas probes installed
- –6 primary samples collected
- Samples not collected at 30 locations due to "non-flow" conditions
 - Local geology and significant rains
- One location destroyed in construction
- -[1,2,3-TCP] in soil gas > PAL at 1 probe
- -[1,2,3-TCP] in soil gas < PAL at 5 probes

The Figure shows the location and number of soil gas probes installed, number of samples collected, and analytical results compared to PALs. The figure also shows the current extent of the 1,2,3-TCP plume at Carve Out 5 (OU-1A).

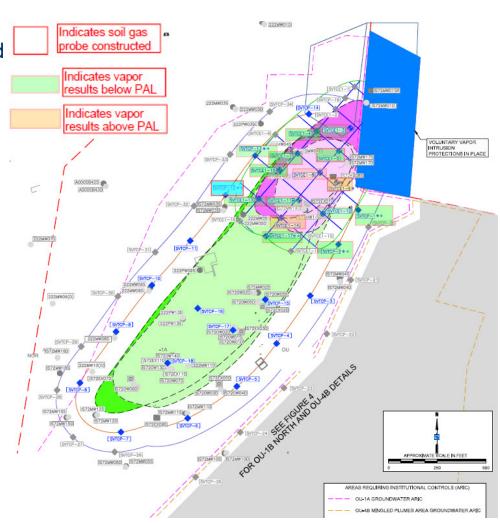
Carve-Out 5: OU-1A Status 1,2,3-TCP Plume and **TCE Plume**

TCE Plume

- -12 primary TCE soil gas probes installed
- -12 primary samples collected
- –No step-out probes required
- -[TCE] in soil gas > PAL at 3 probes

The figure on the slide shows the location and number of soil gas probes installed, number of samples collected, and analytical results compared to PALs. The figure also shows the current extent of the TCE plume at Carve-Out 5 (OU-1A).

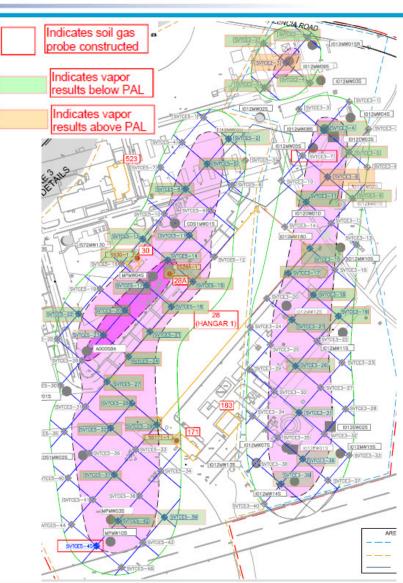
Carve-Out 5: OU-1B North and Mingled Plumes Area Status TCE Plume

OU-1B North

- -13 primary soil gas probes installed
- –7 step-out soil gas probes installed
- Sample not collected from 1 step-out probe, due to "non-flow" conditions
- -[TCE] in soil gas > PAL at 2 probes

Sub-slab Probes

- –3 sub-slab probes installed/sampled
- Bldgs 28A, 30 & 171: selected for plume proximity and potential reuse
- [TCE] in soil gas < the PAL in all 3 samples</p>

The figure on the slide shows the location and number of soil gas probes installed, number of samples collected, and analytical results compared to PALs. The figure also shows the current extent of the TCE plumes at Carve-Out 5 (OU-1B North and MPA).

Buildings 28, 30, and 171 were part of a subset of buildings identified by the City of Tustin as having potential re-use value. Building 28A is northwest of the hangar. These buildings were selected from the larger set of structures due to their proximity to the groundwater plumes. All sub-slab samples collected from those buildings had concentrations less than the TCE sub-slab PAL.

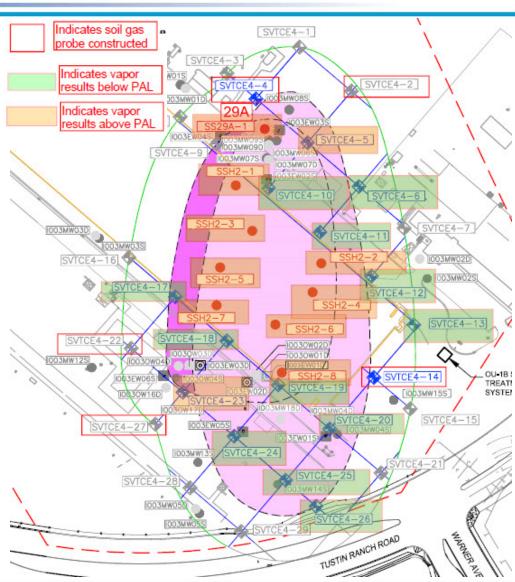
Carve-Out 6: OU-1B **South Status**TCE Plume

- -16 primary soil gas probes installed
- –3 step-out soil probes installed
- –Samples collected at 14 primary soil gas probes
- Samples not collected at 2 primary and 3 step-out probes due to "nonflow" conditions
- -[TCE] in soil gas > PAL at 2 probes

Sub-slab Probes

- -9 sub-slab probes installed
- -[TCE] in soil gas > PAL at all 9 subslab probes

The figure on this slide shows the location and number of soil gas probes installed, number of samples collected, and analytical results compared to PALs. The figure also shows the current extent of the TCE plume at Carve-Out 6 (OU-1B South).

Ms. Patricia Hannon (RWQCB) asked what the maximum TCE concentration was reported in the subslab samples at Hangar 2. Mr. Pribyl replied that he would be able to provide her that information once the analytical results are validated.

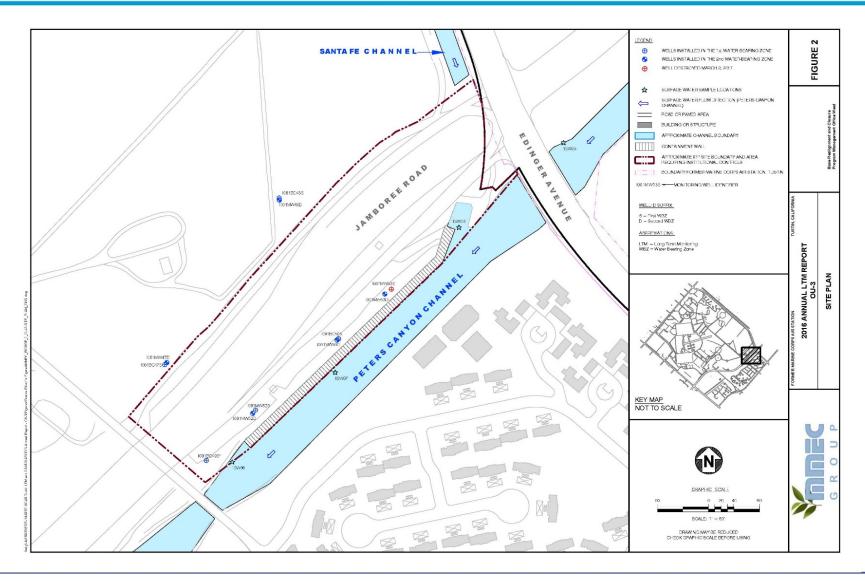
Background – OU-3 Site Map

The figure on this slide shows OU-3 and the current groundwater monitoring well network. Mr. Bollweg stated that the site is composed of the Moffett Trenches, located near the southern end of the site next to Moffett Road, as well as the crash crew burn pits that were located in the central part of the site and going towards the north. He identified site features on the map shown on the slide to include Jamboree Road and Peters Canyon Channel.

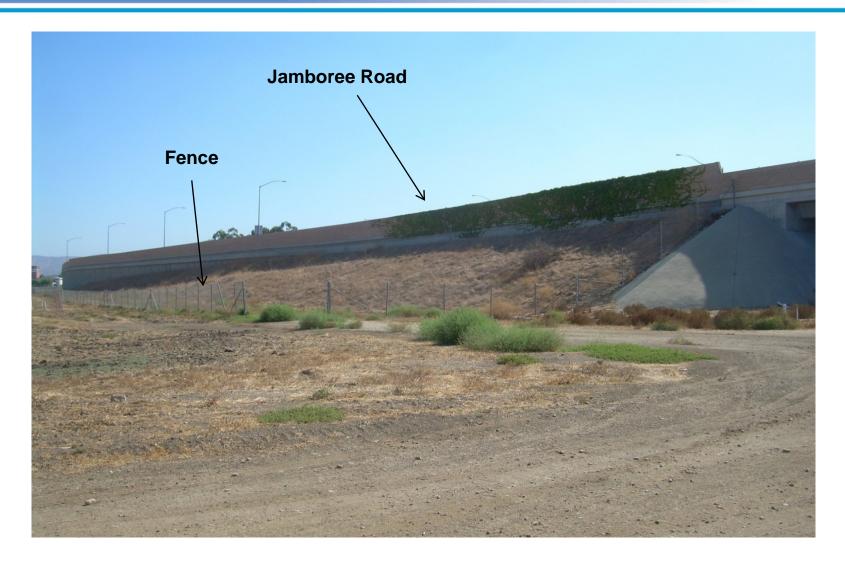
Slide 8 – Remedy Overview (continued).

This slide shows a photograph of the site looking west to east. Mr. Bollweg explained that the fence shown in the photograph around the site was installed to protect the monitoring wells that are used for groundwater monitoring. The photograph also shows the location of Jamboree Road relative to the site. He explained there is a landfill cap over the site that includes 20 feet of fill material.

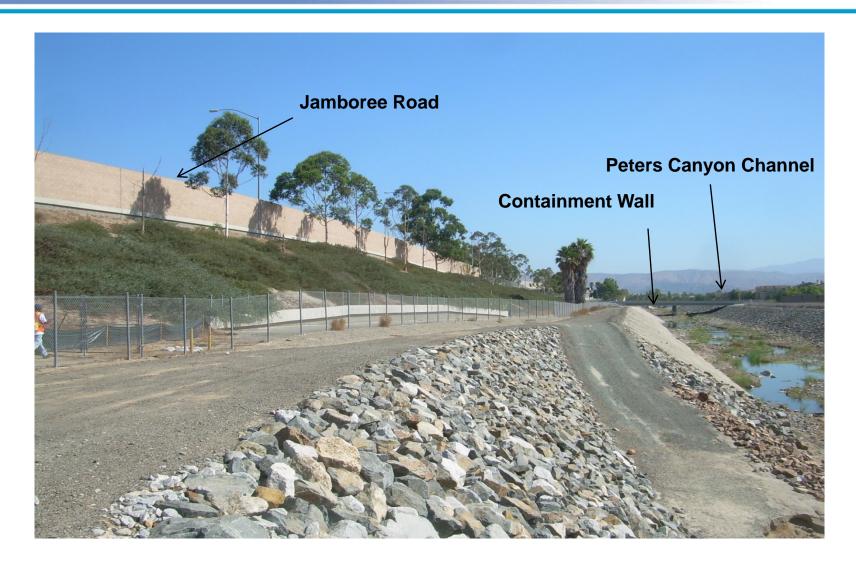
Slide 9 – Remedy Overview (continued).

This slide shows a photograph of the site looking north from the western side of the site. Jamboree Road is shown behind the wall.
